# Membertou Flood Study

Steven Stone, P.Eng

First Nations Land Management Resource Centre

Climate Change Workshop

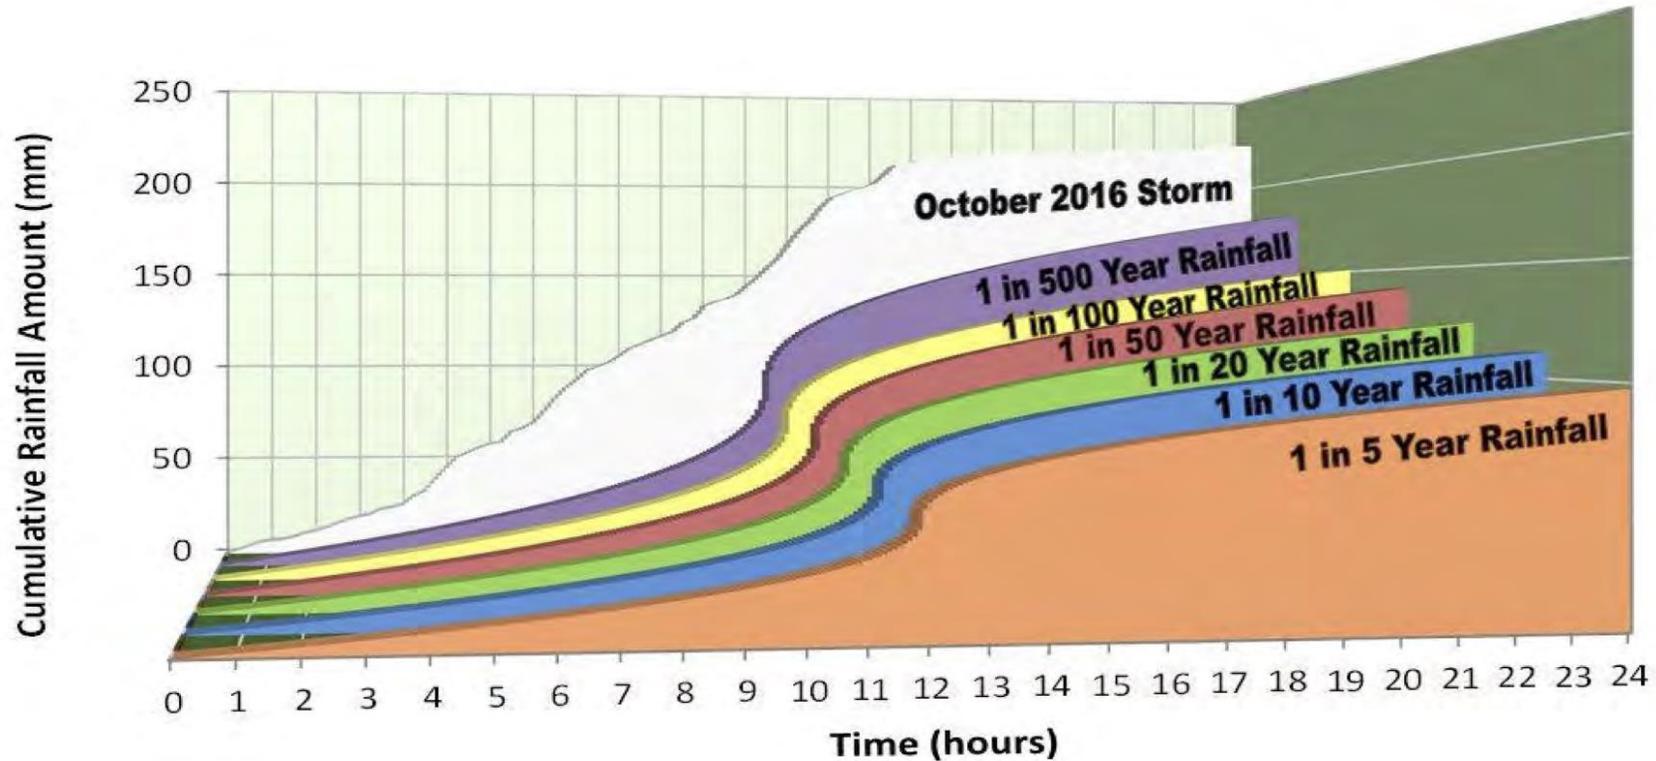
Figure 1.2: Cumulative Rainfall Amounts for Design Storms (based on IDF Curves for Sydney Airport) and the October 2016 Storm

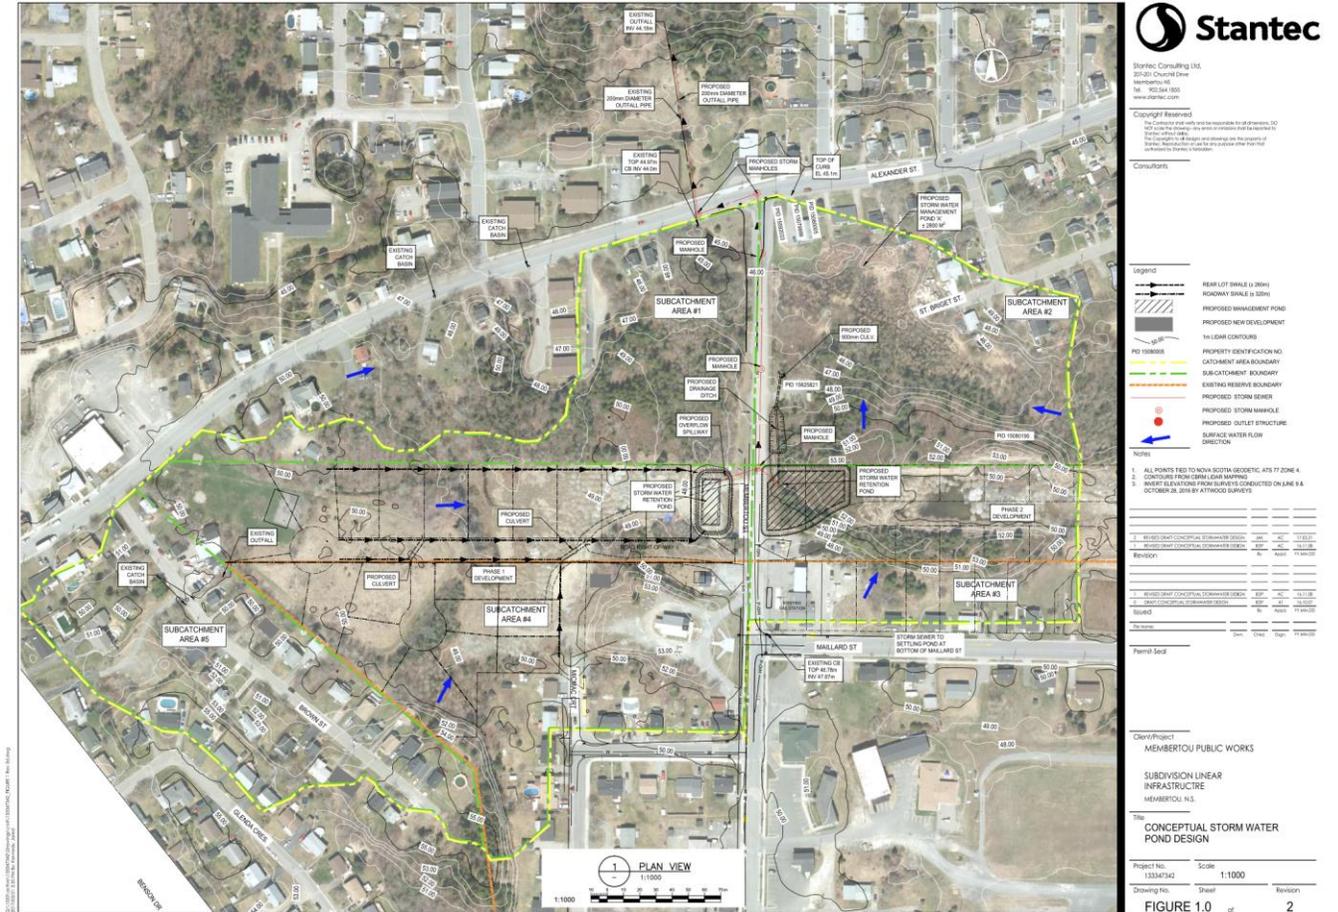
# Area 1: Membertou Street & Muin Awti

This area is in a bowl with no overland drainage corridor

New subdivision cannot proceed without new storm sewer installed on Membertou Street

Cape Breton Regional Municipality currently studying new storm sewer on Alexandra Street that would also include storm sewer on Membertou Street

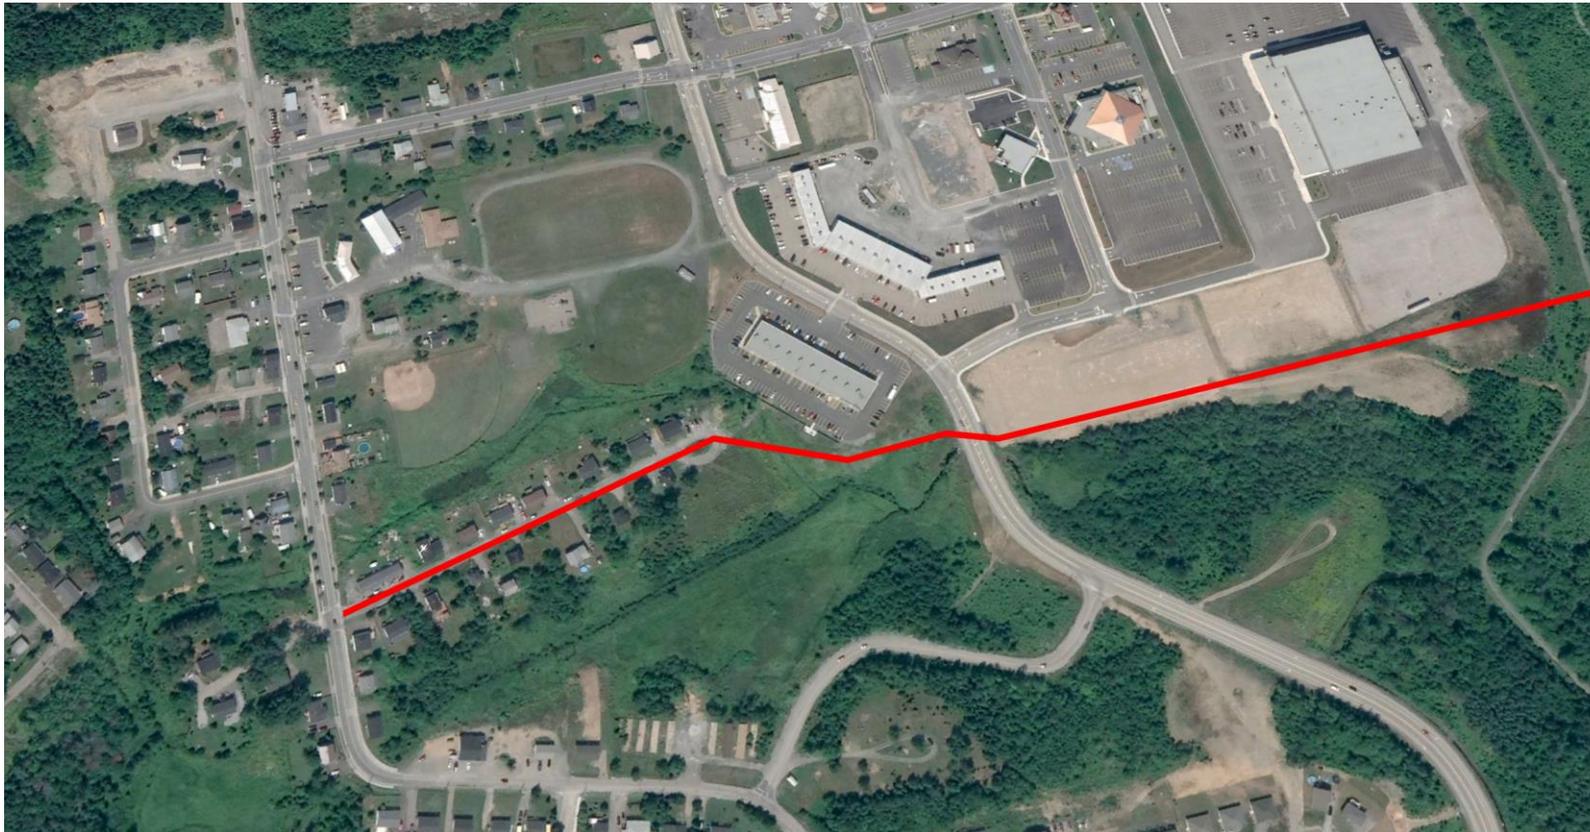
# Gallagher Street Cross Country Sewer

- Proposed cross-country sanitary sewer
- Existing sewer too shallow with lots of I&I
- New sewer to flow in opposite direction
- New sewer to take all flows from Tupsi Drive & Bradley Street
- This reduces load on existing sewers on Membertou Street and Micmac Crescent

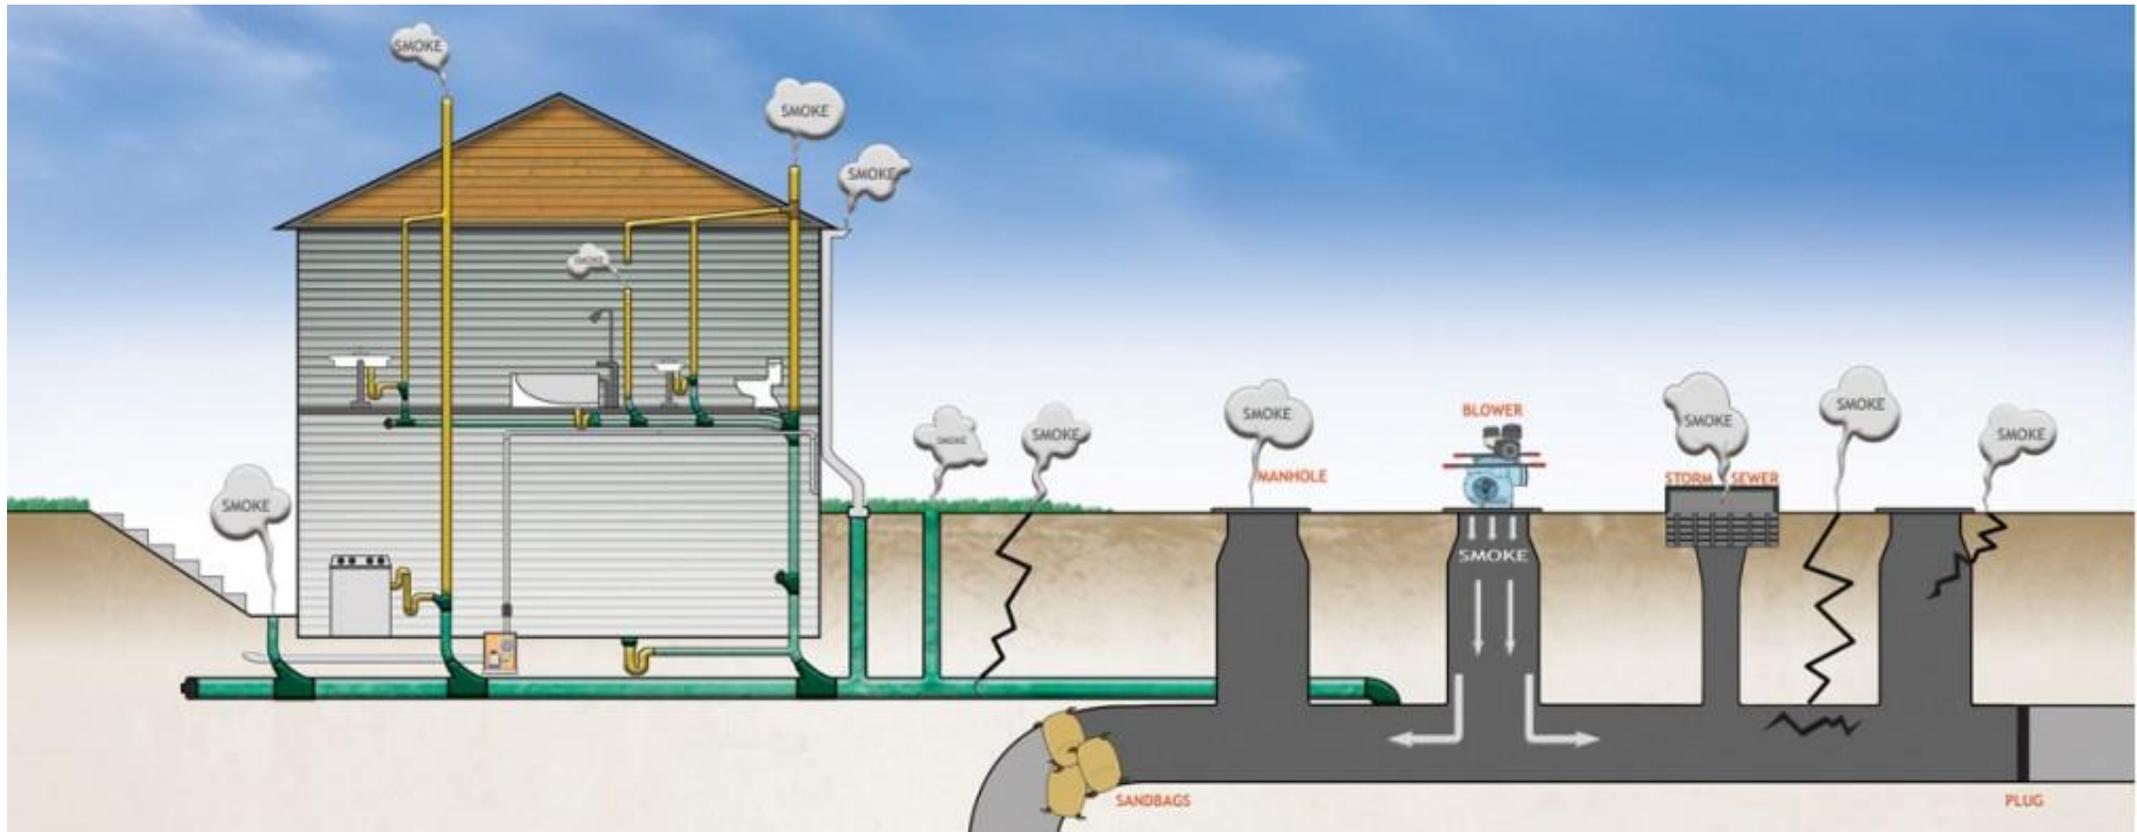
# Smoke Testing

Determined which houses had sump pumps tied into Sanitary Sewer

Determined which houses had roof gutters tied into Sanitary Sewer

Determined which houses had weeping tile tied into Sanitary Sewer

Located leaking manholes

In total, 37 issues identified that need to be addressed
