# Membertou Flood Study

Steven Stone, P.Eng

First Nations Land Management Resource Centre

Climate Change Workshop

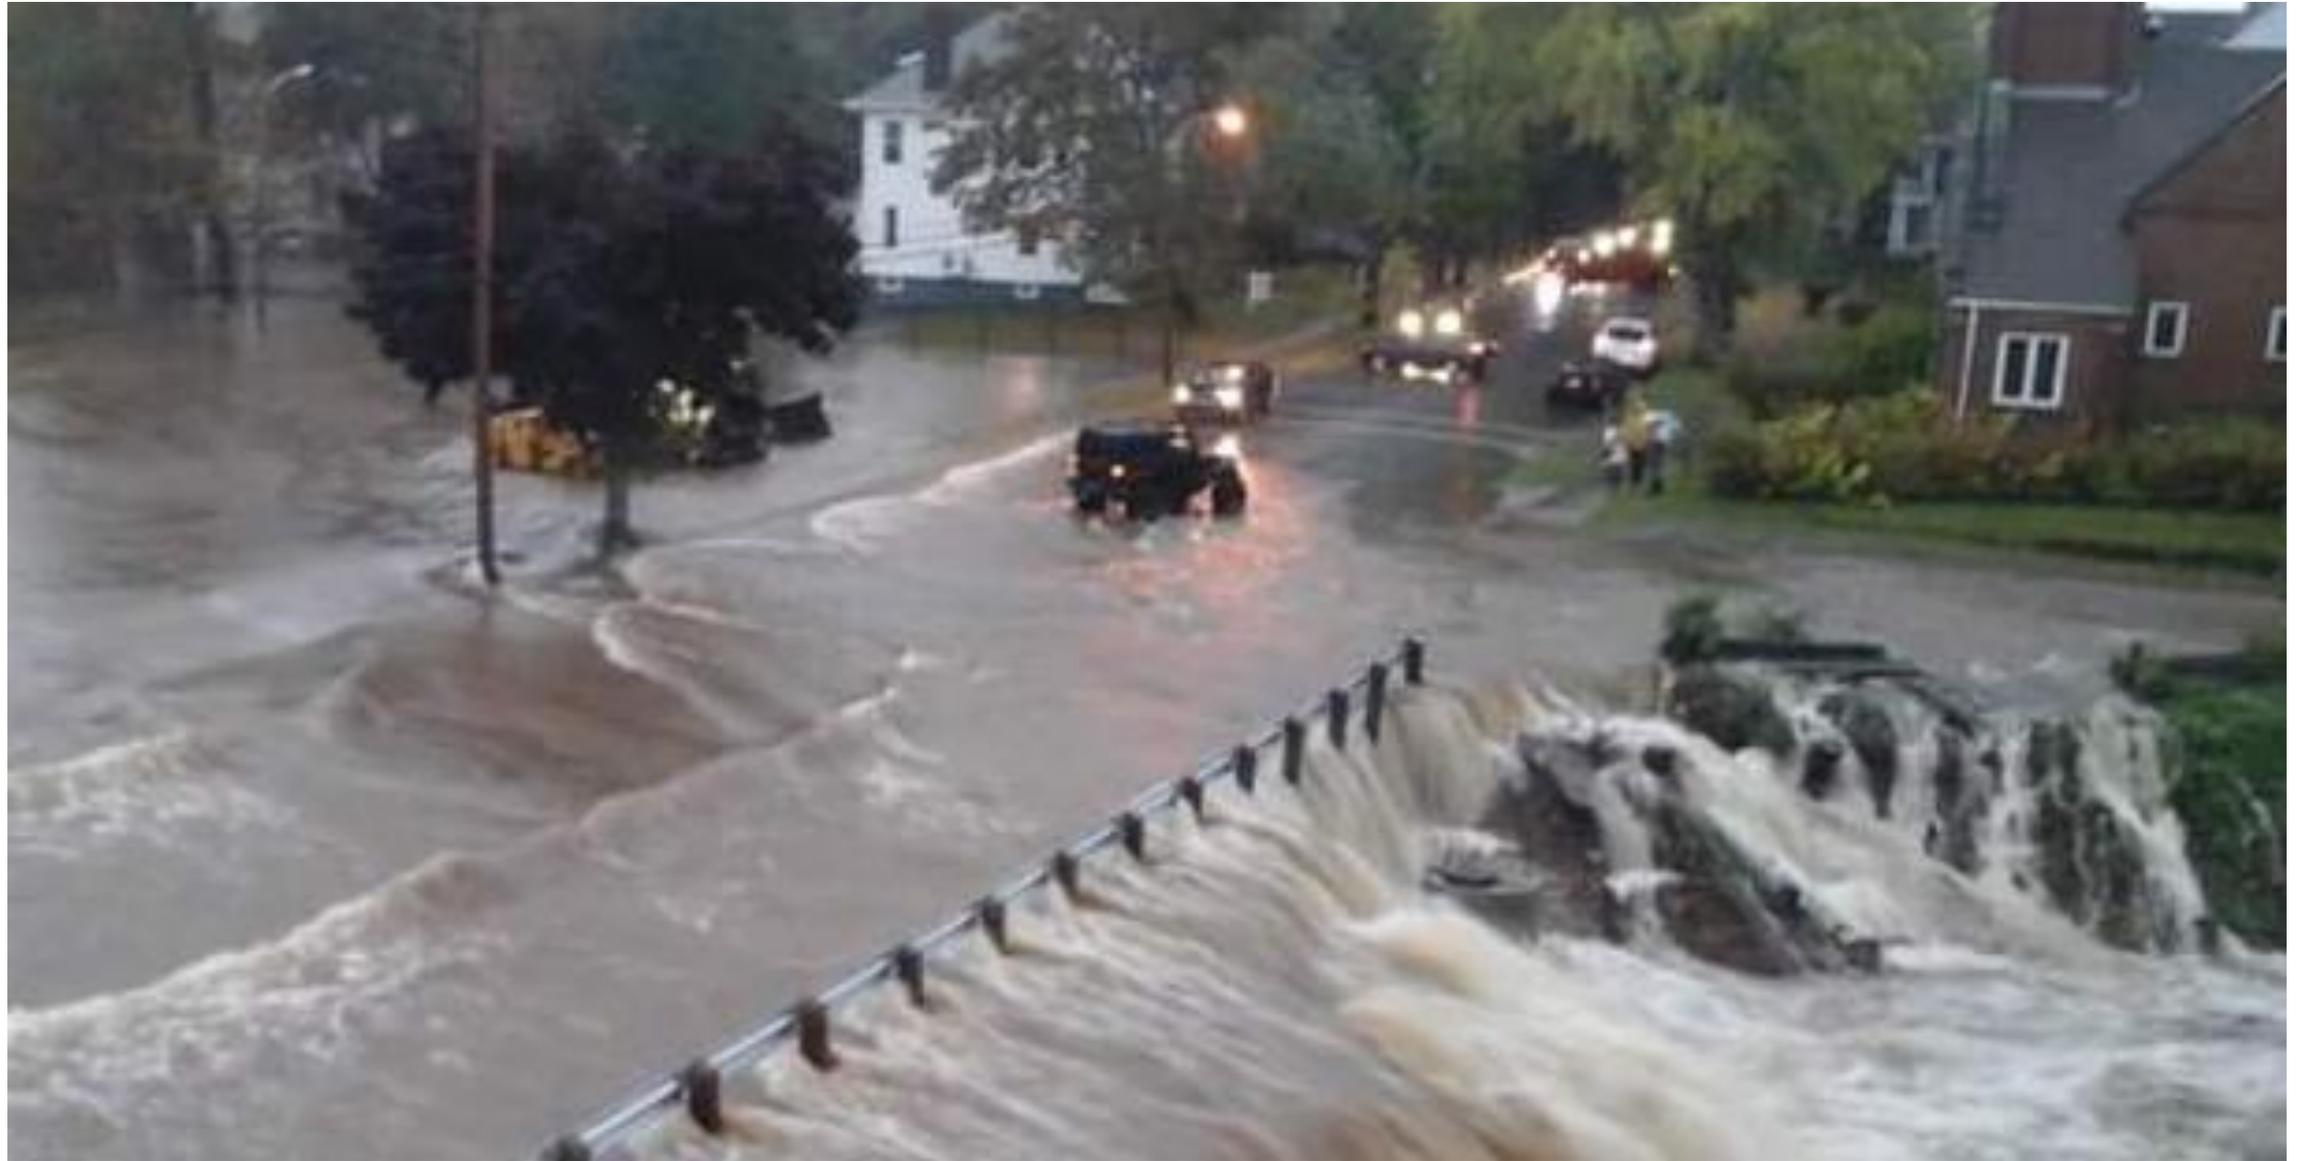
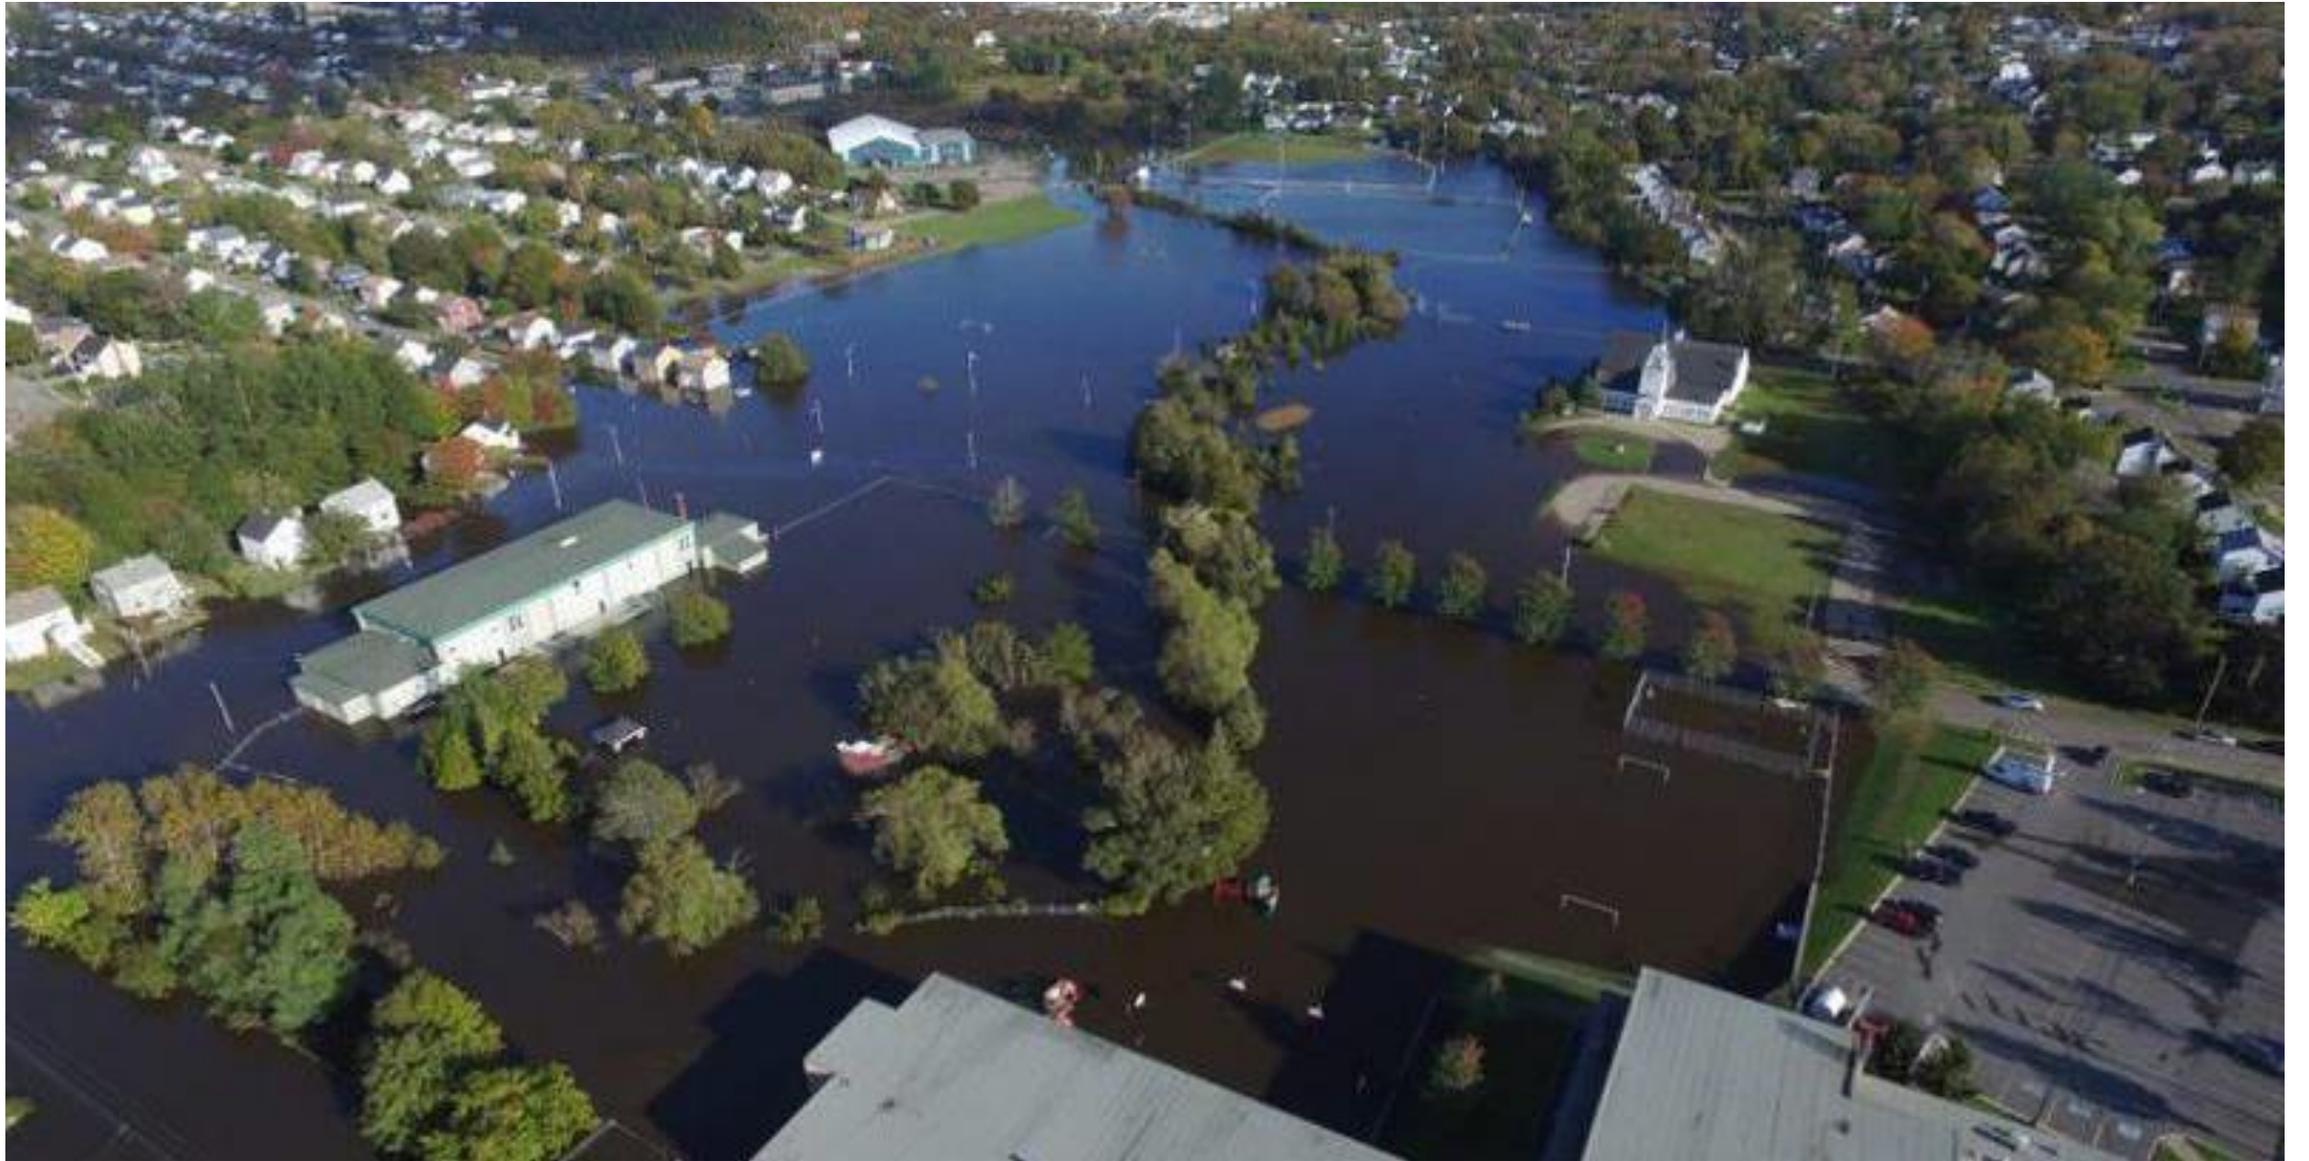
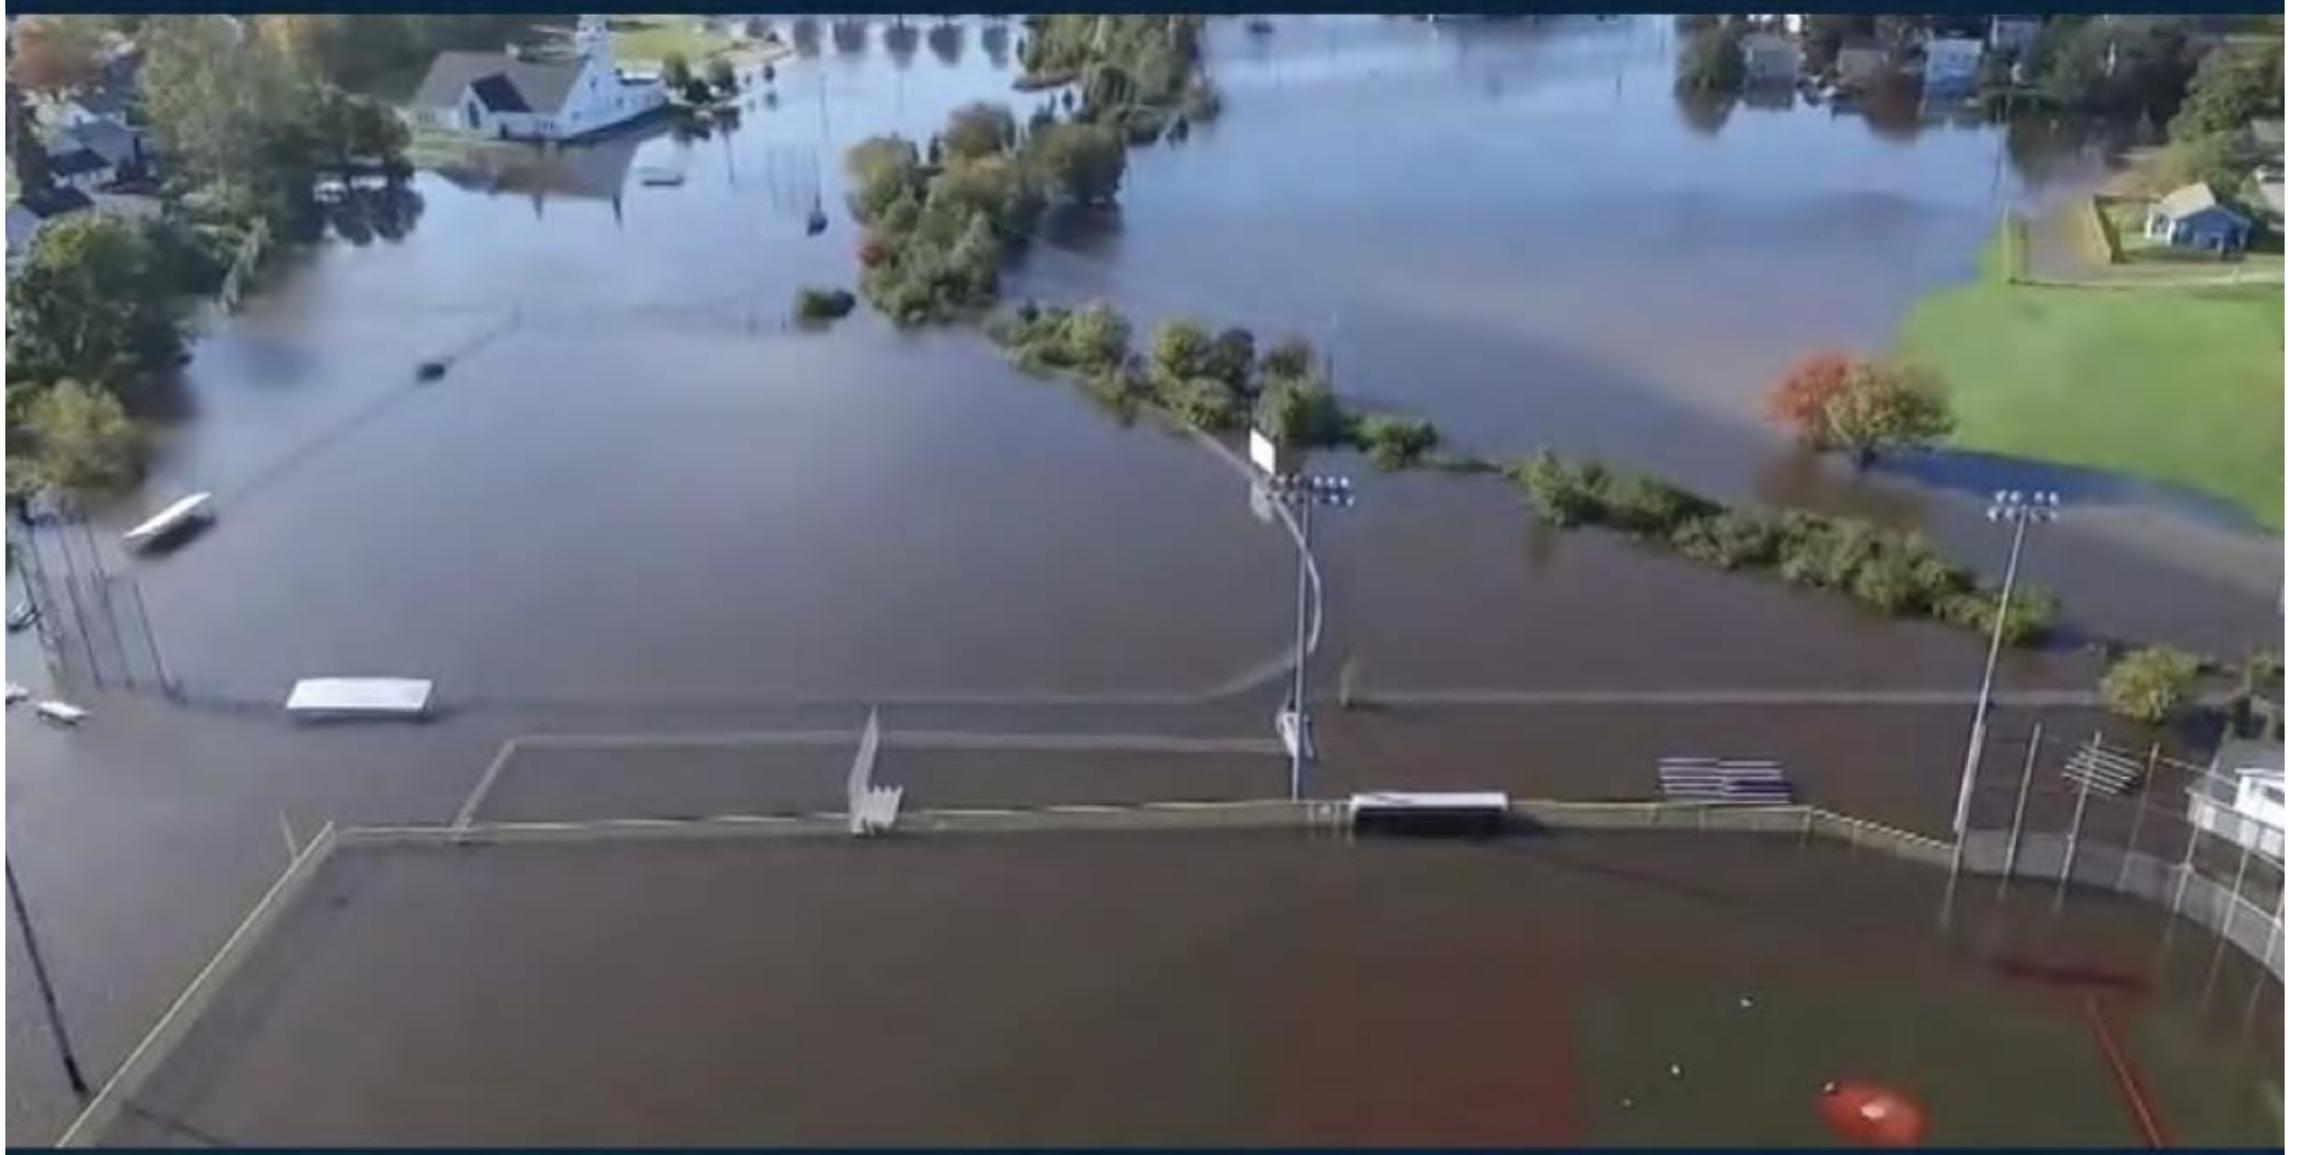
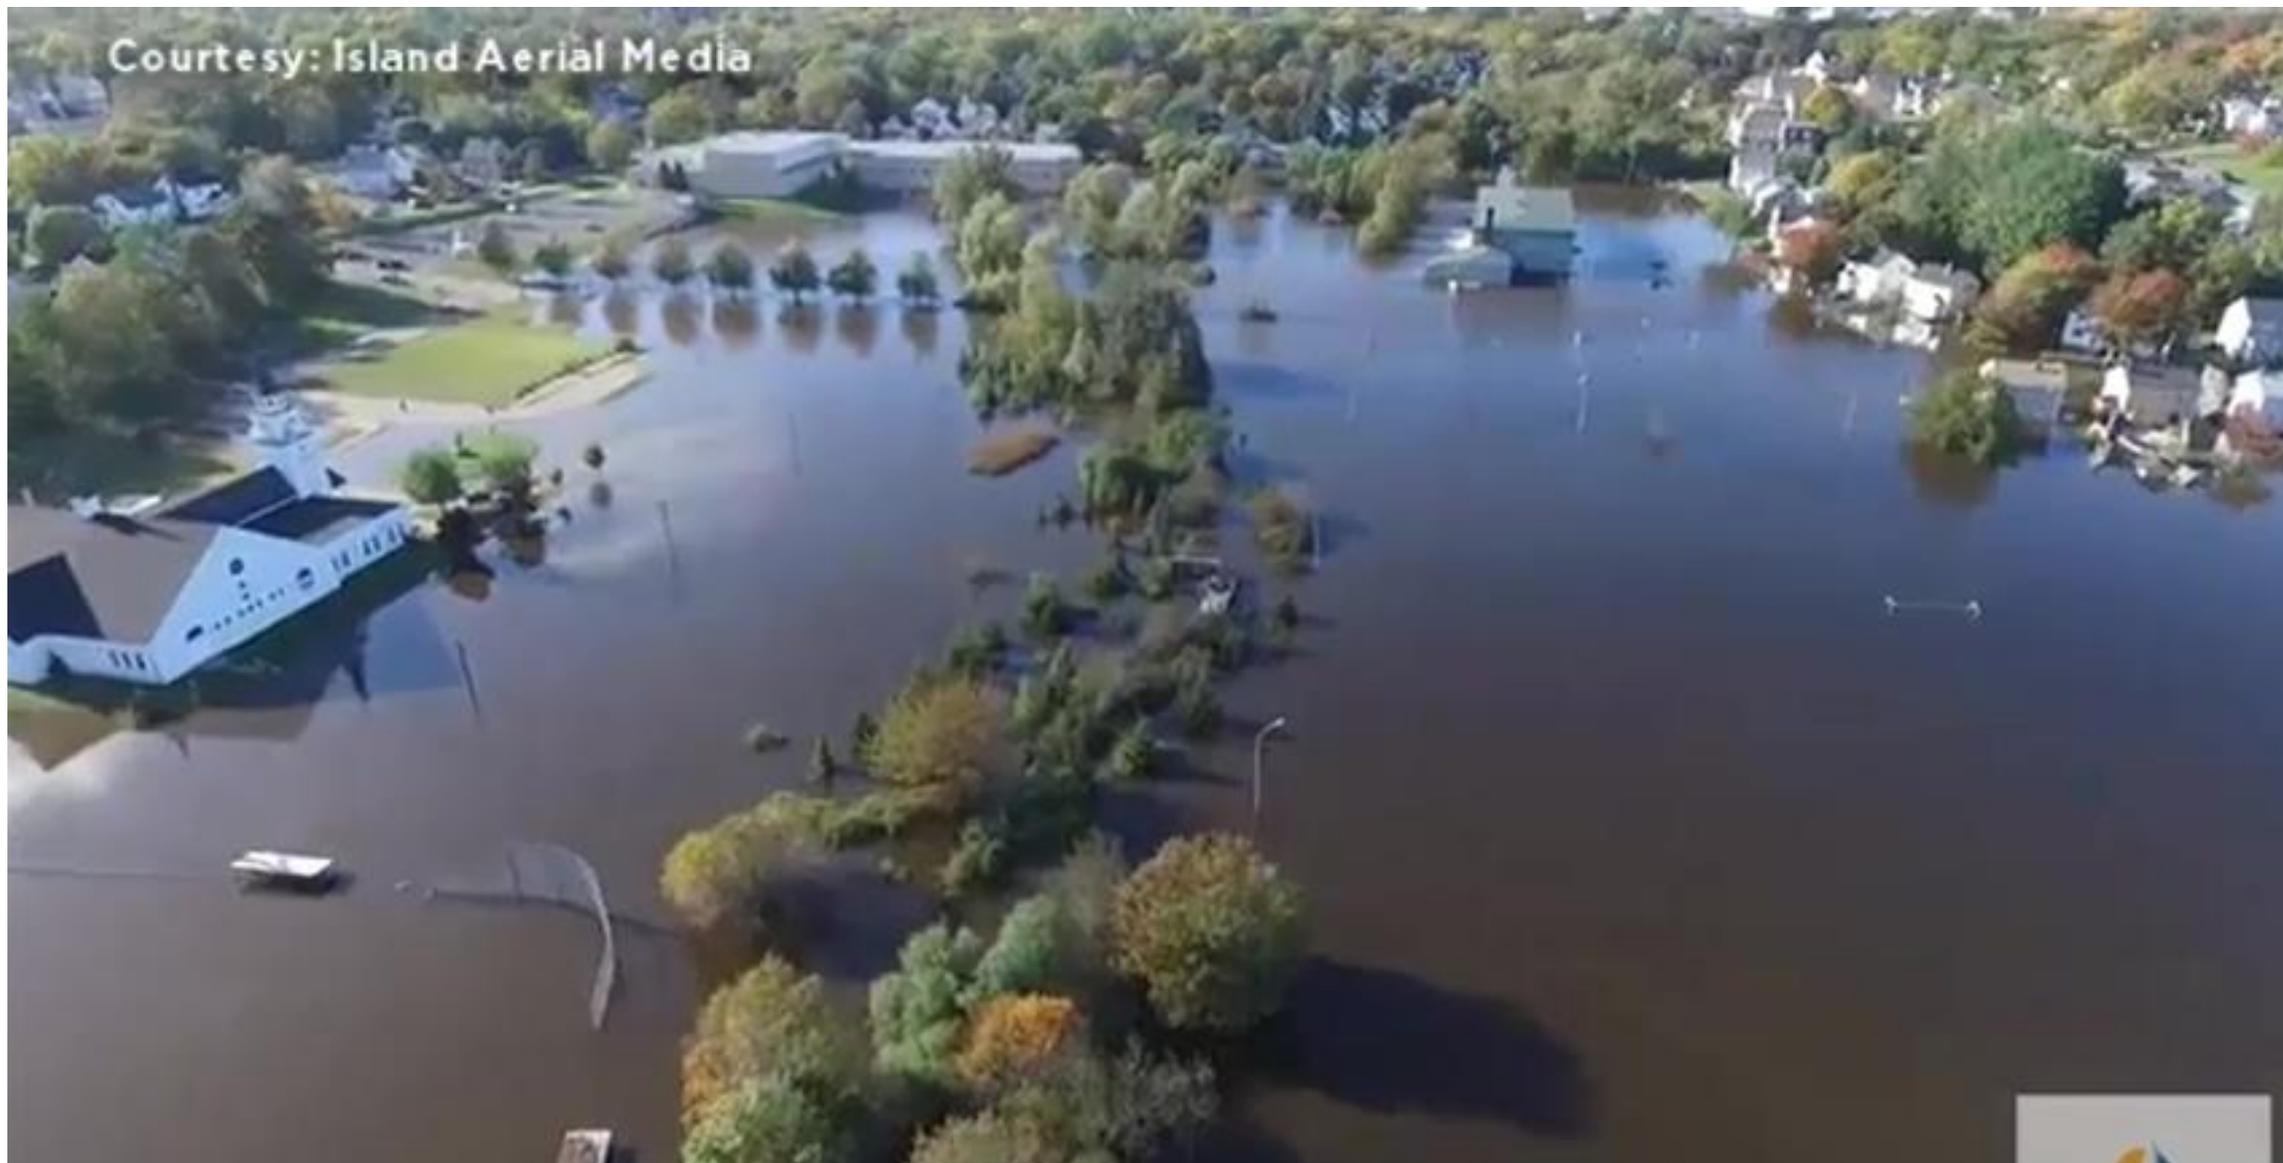
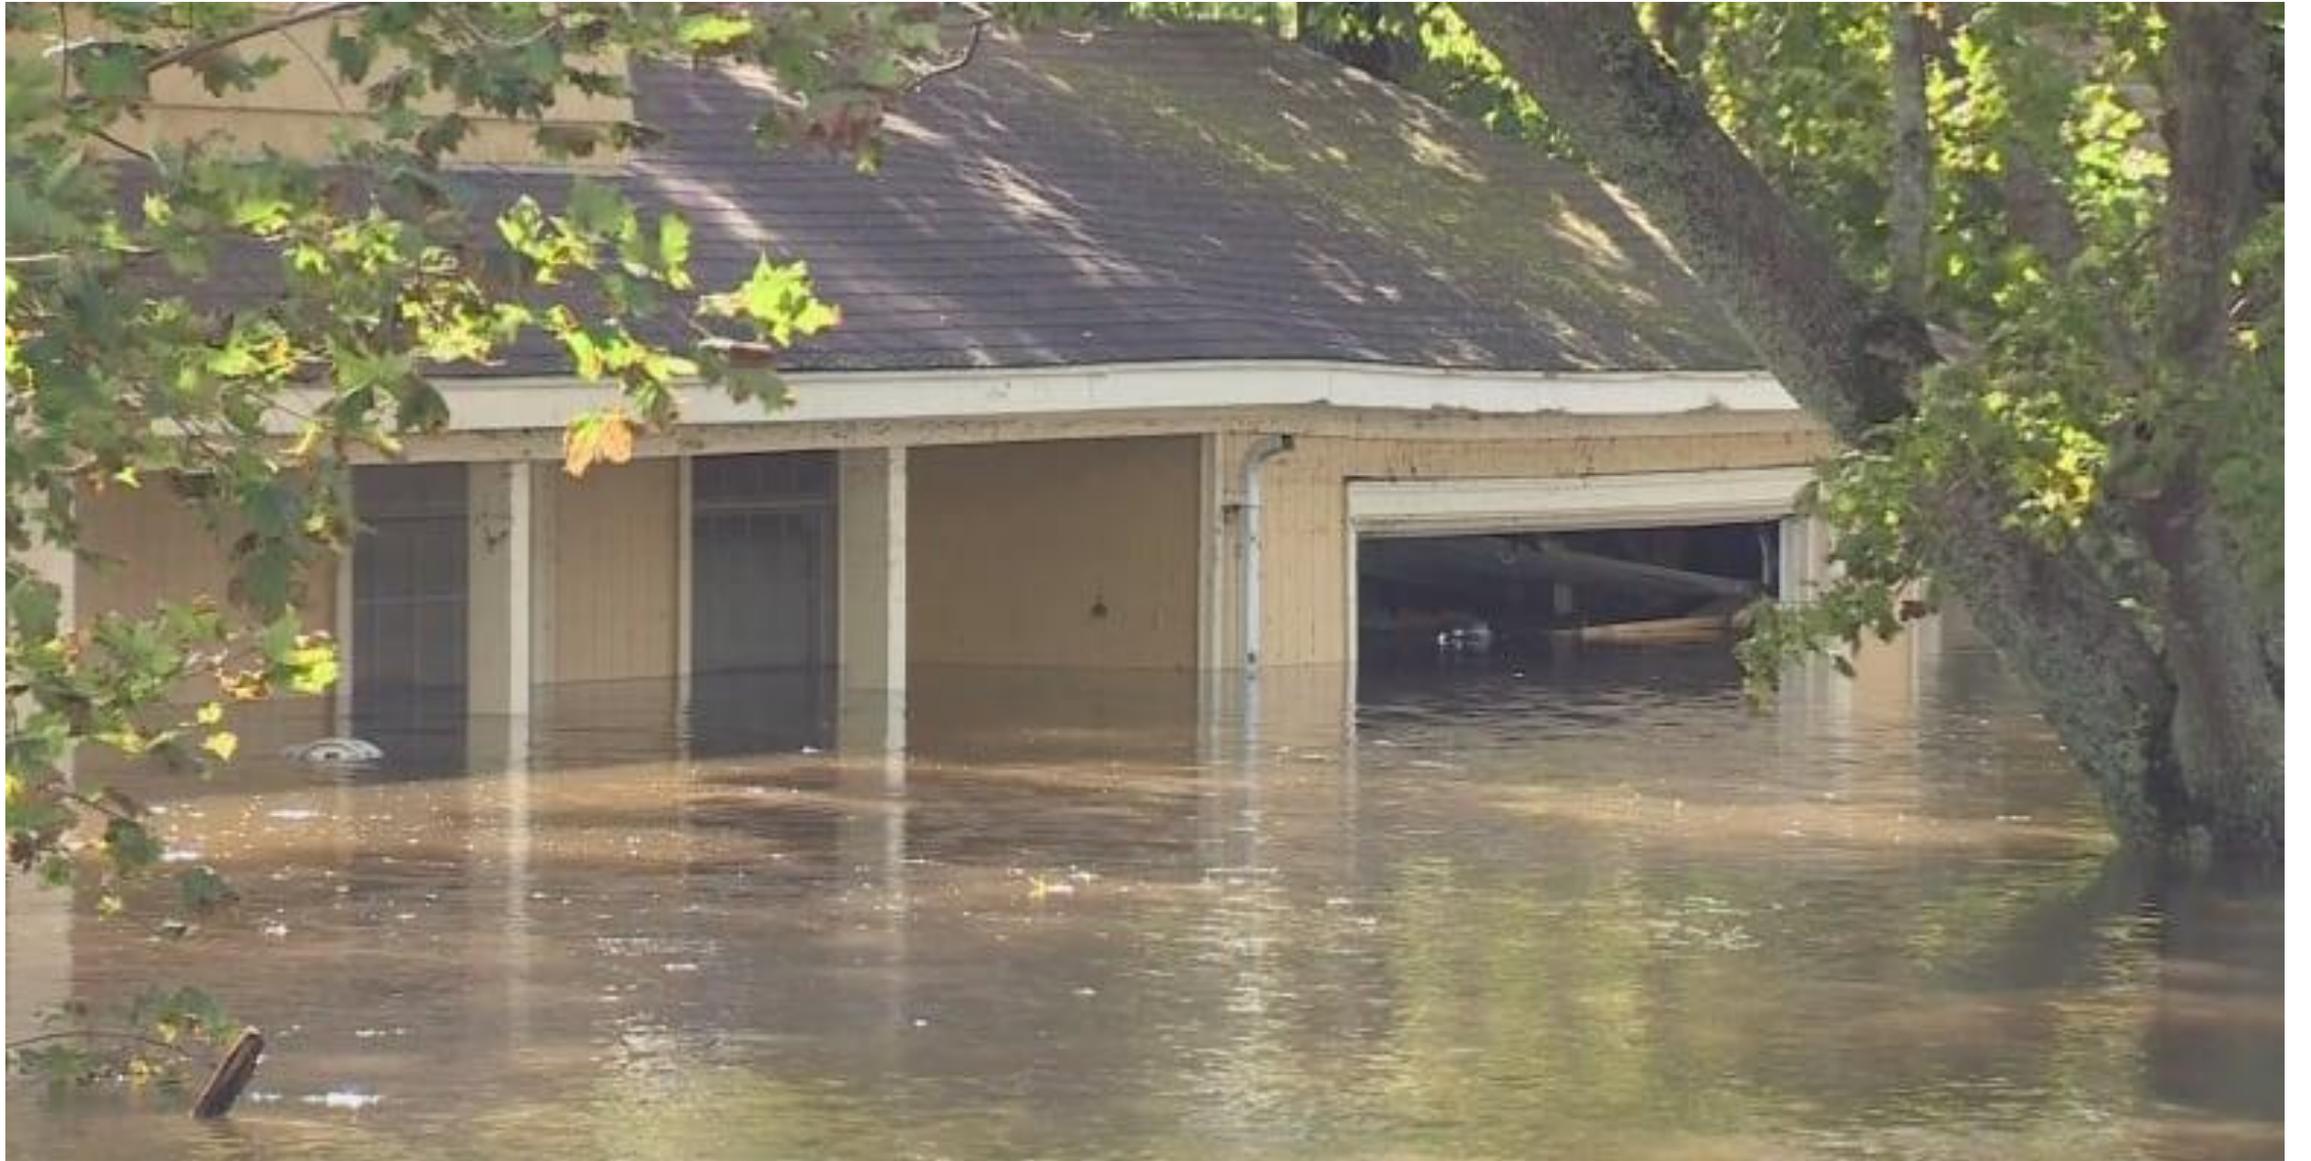
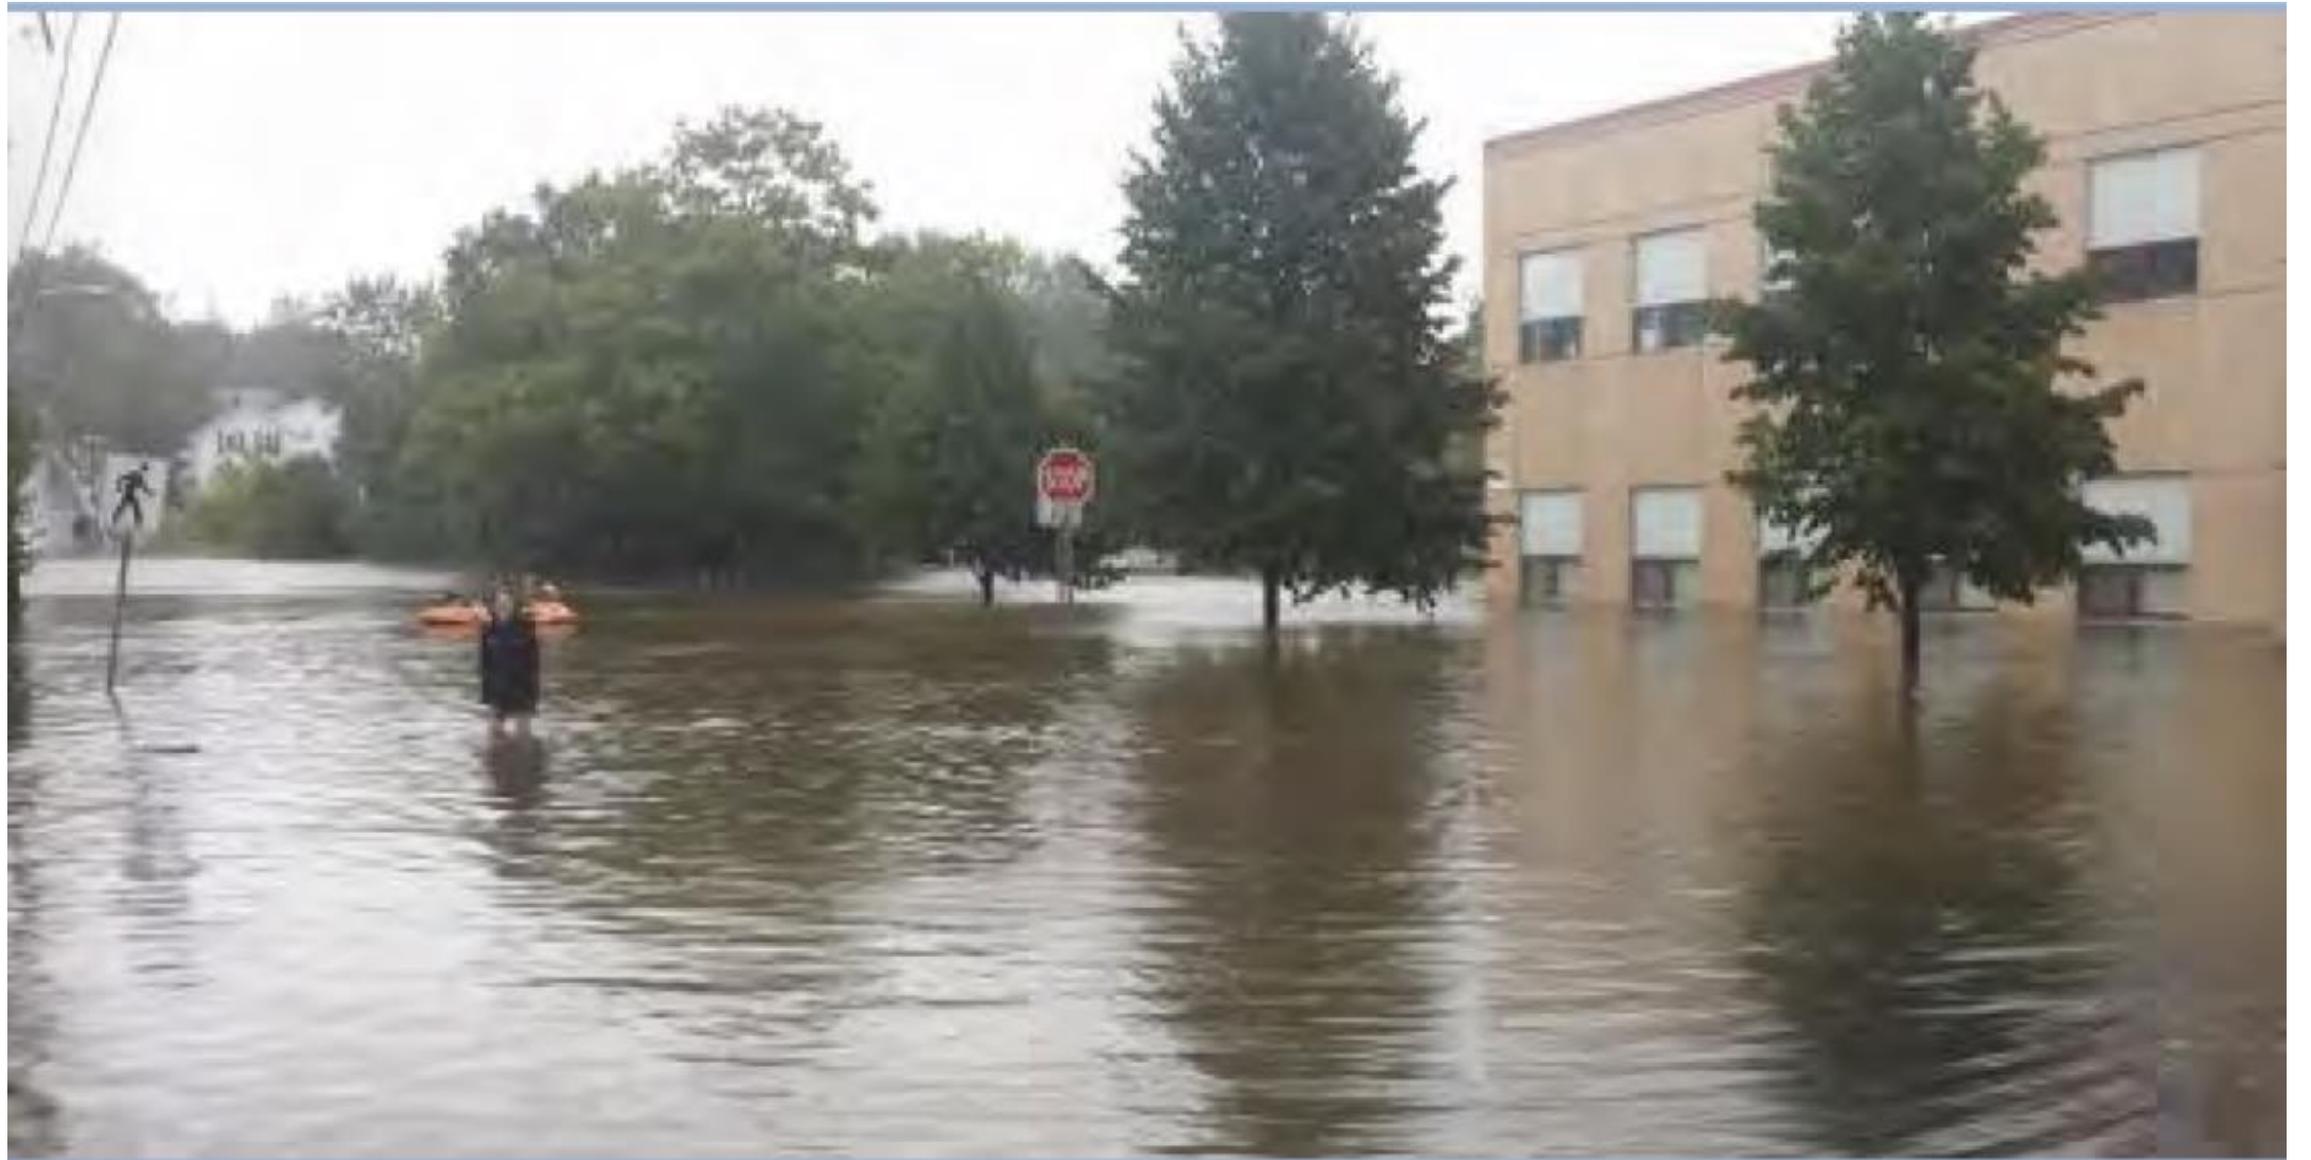
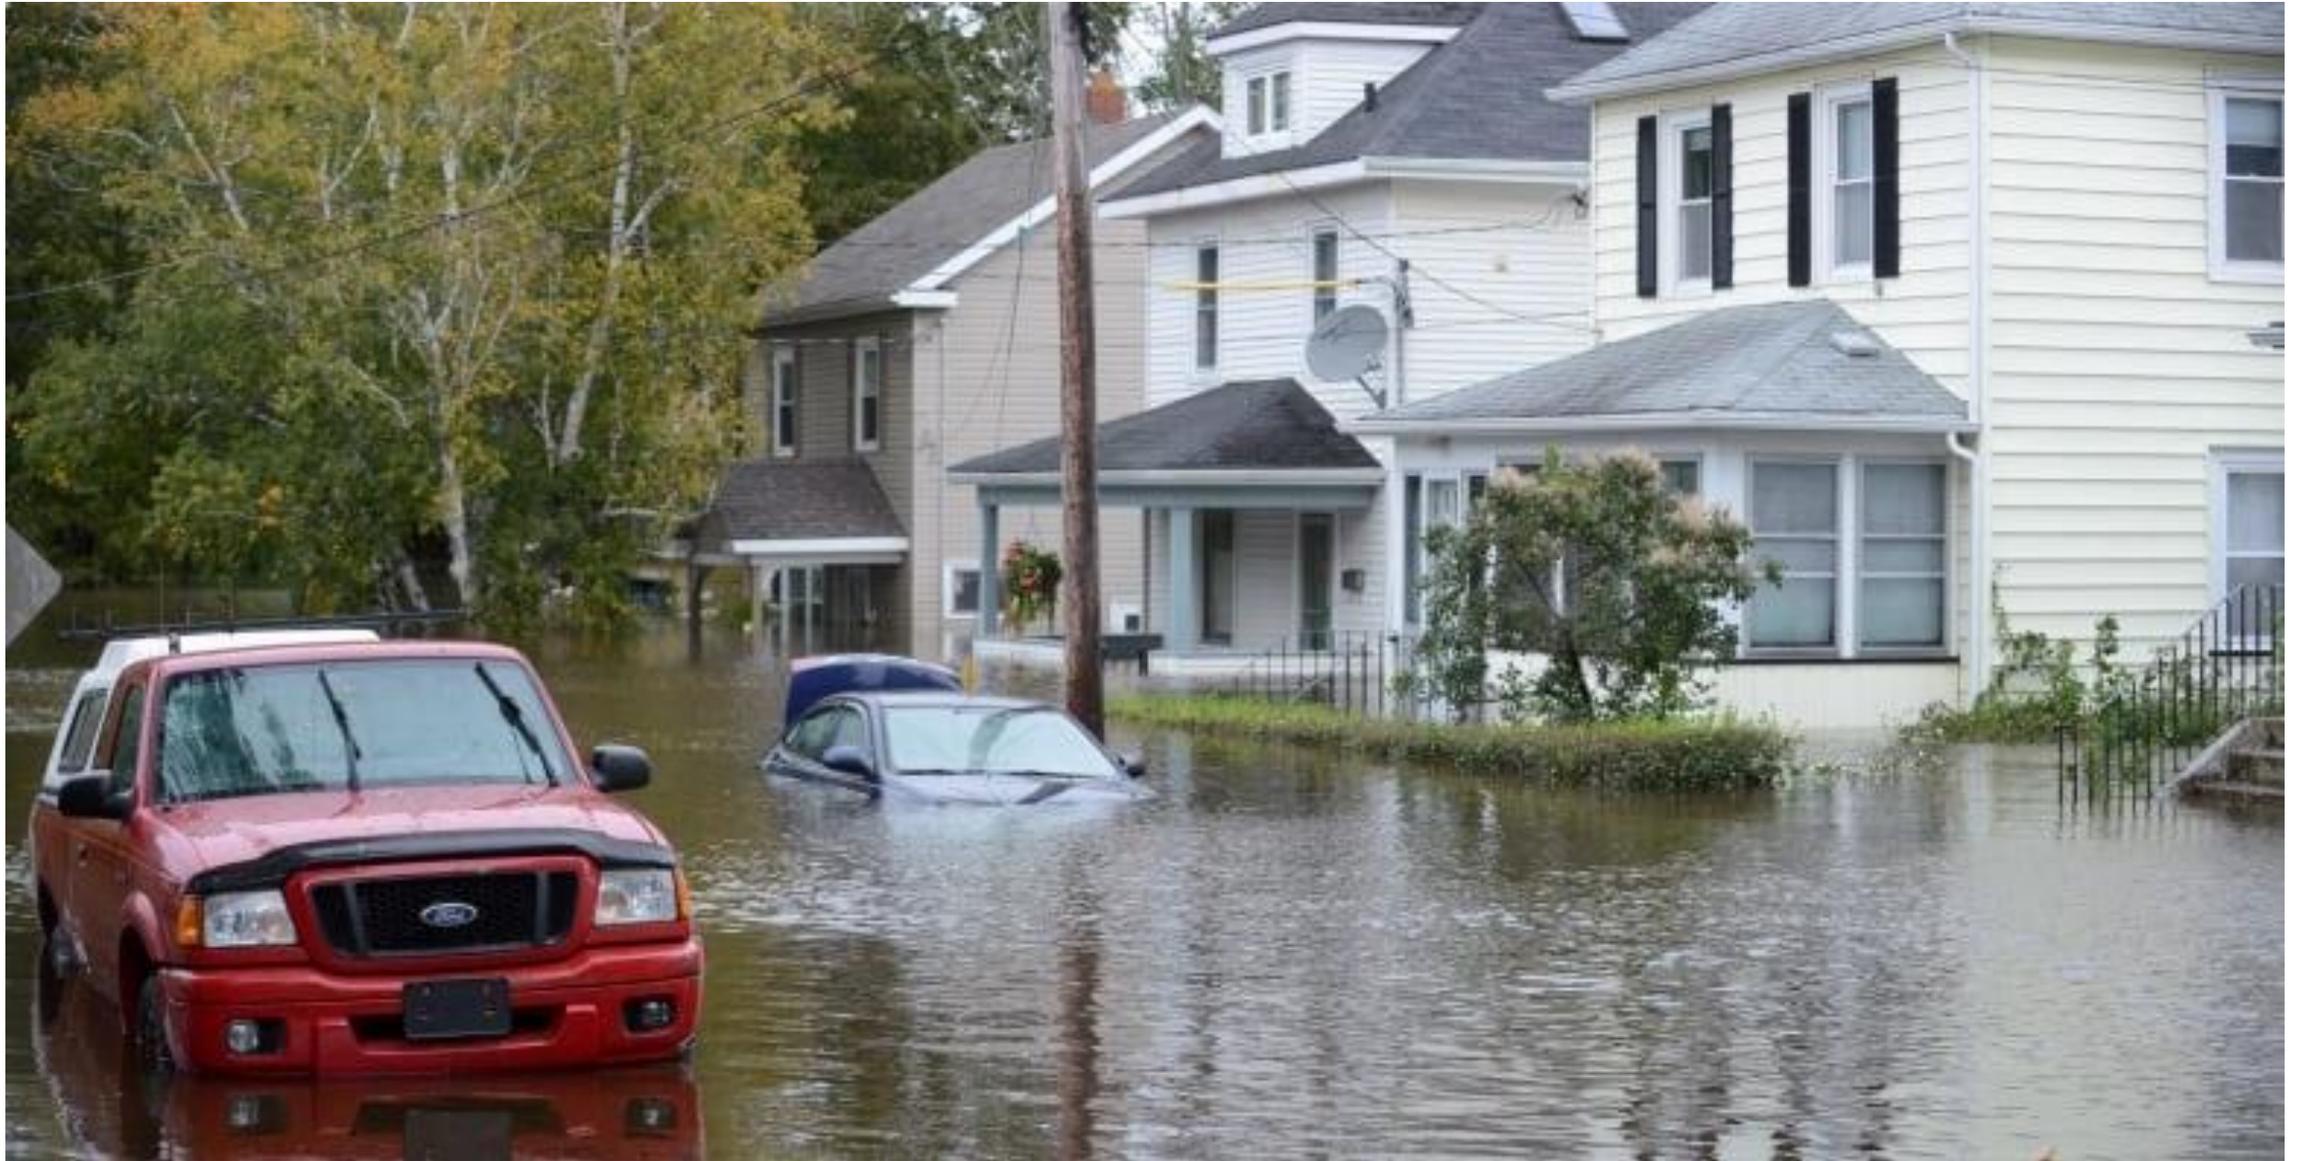
Reservoir Brook  
(Wentworth Creek)  
&  
Wash Brook

Courtesy: Island Aerial Media

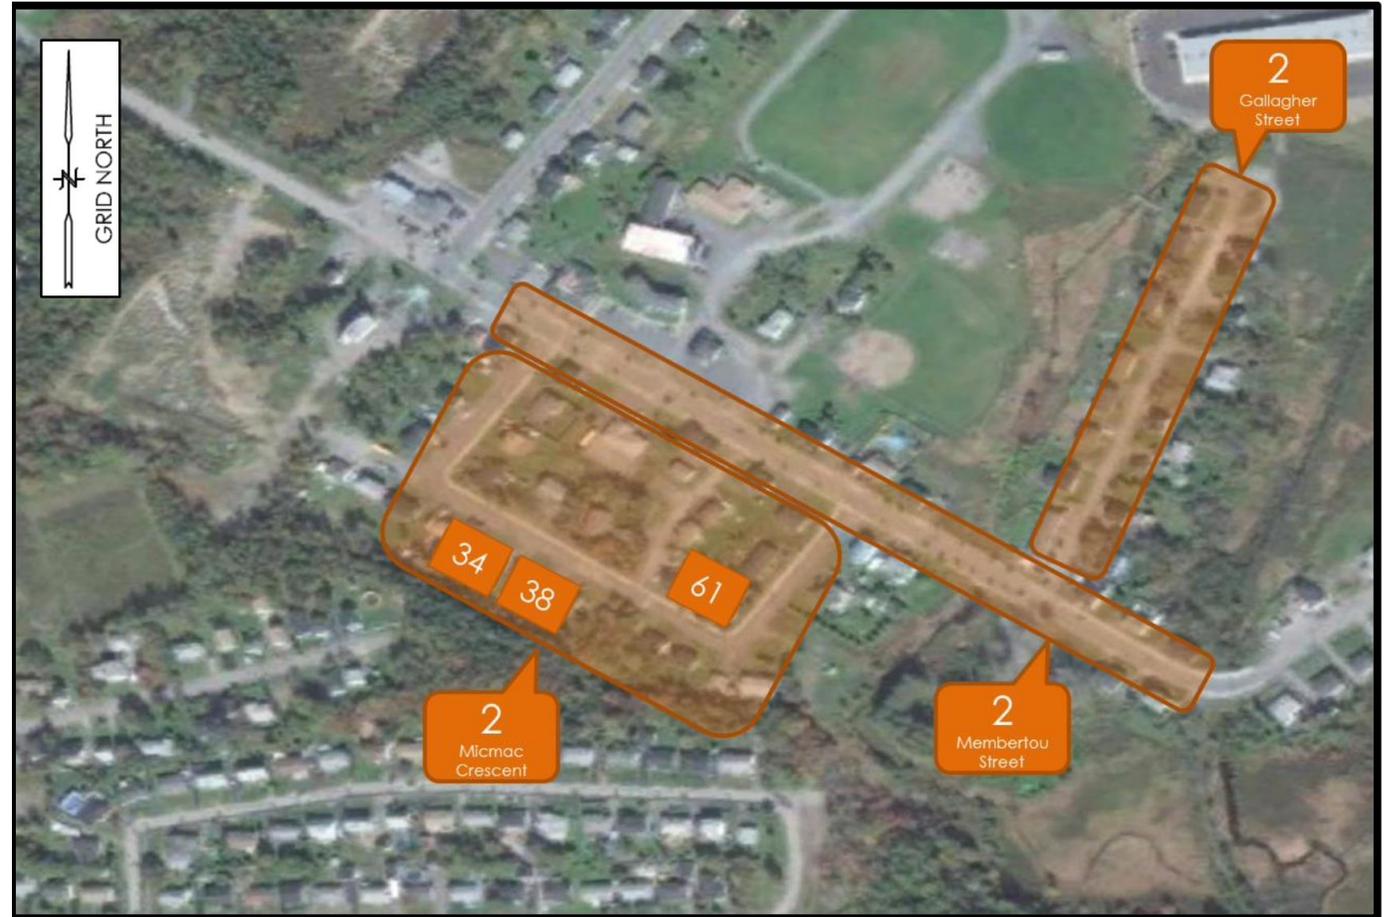
Area 2:  
Micmac  
Crescent,  
Membertou  
Street &  
Gallagher  
Street

- Proposed cross-country sanitary sewer
- Existing sewer too shallow with lots of I&I
- New sewer to flow in opposite direction
- New sewer to take all flows from Tupsi Drive & Bradley Street
- This reduces load on existing sewers on Membertou Street and Micmac Crescent

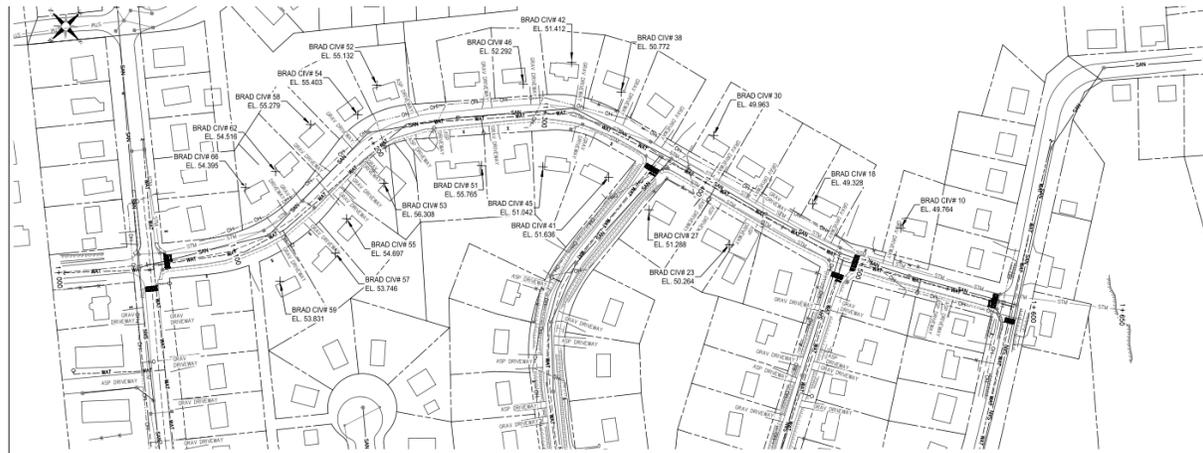
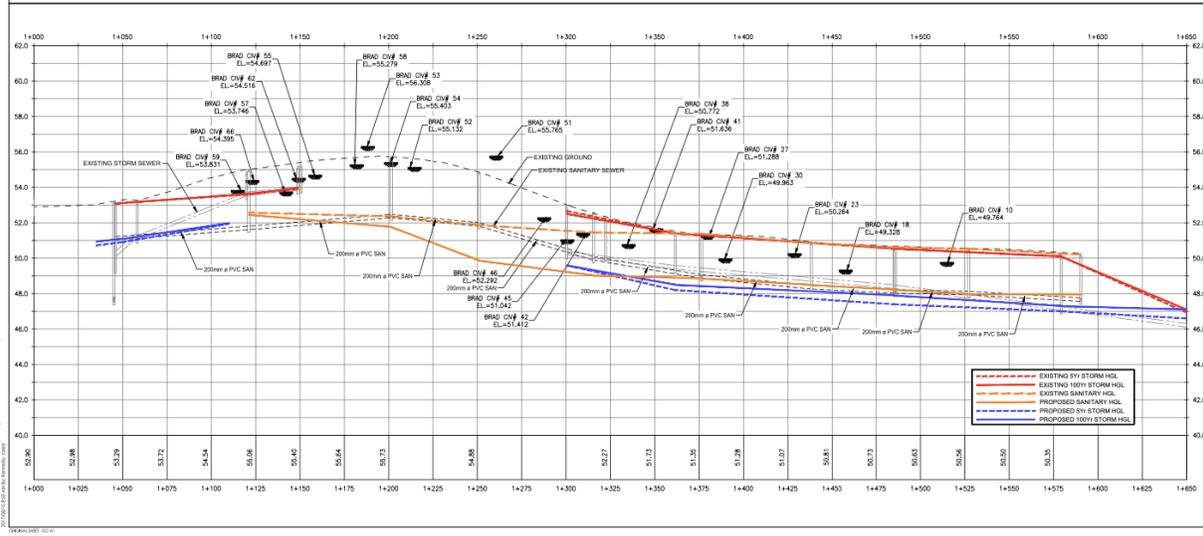
HYDRAULIC GRADELINE STORM  
BRADLEY STREET

# Existing SAN Sewer (Actual) - Bradley Street

Bradley Street Sanitary Sewer Model

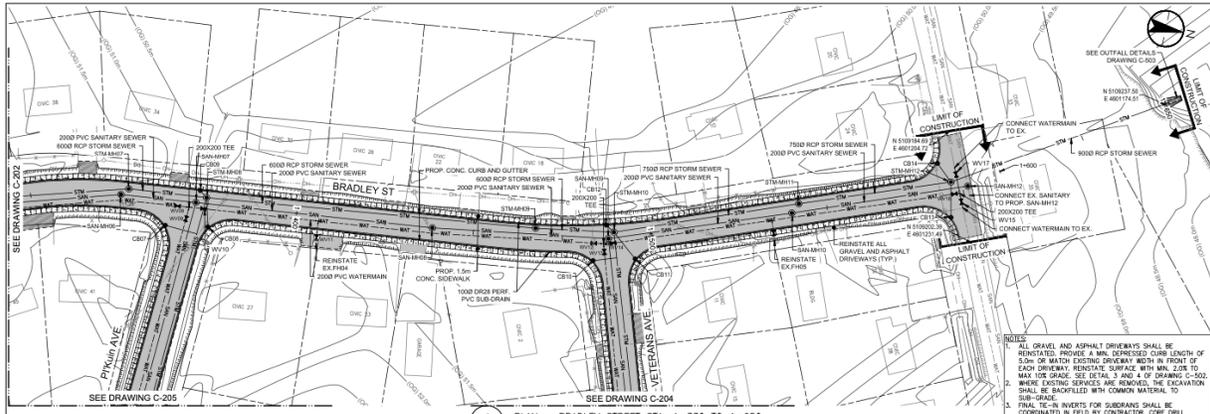
1 PLAN - BRADLEY STREET STA. 1+330 TO 1+650  
SCALE: 1:500

# Bradley Street Record Drawings with Modelling Results

- New Curb, Gutter, Sidewalk, and Asphalt
- Existing Storm Sewer Undersized
- Reused Existing Storm Sewer for Weeping Tile Drains Only
- New Storm Sewer and Catch Basins Installed for Surface Water
- Two New Stormwater Outfalls
- Replaced Existing Stormwater Outfall with Larger Pipe at Higher Elevation
- Repairs to Existing Sanitary Sewer to Reduce I&I
- Installed Backflow Valves on Sanitary Laterals
- Regraded Yards
- Full Reconstruction Would Have Cost about \$3.5M
- Bradley Street Upgrades/Repairs Cost \$1.1M

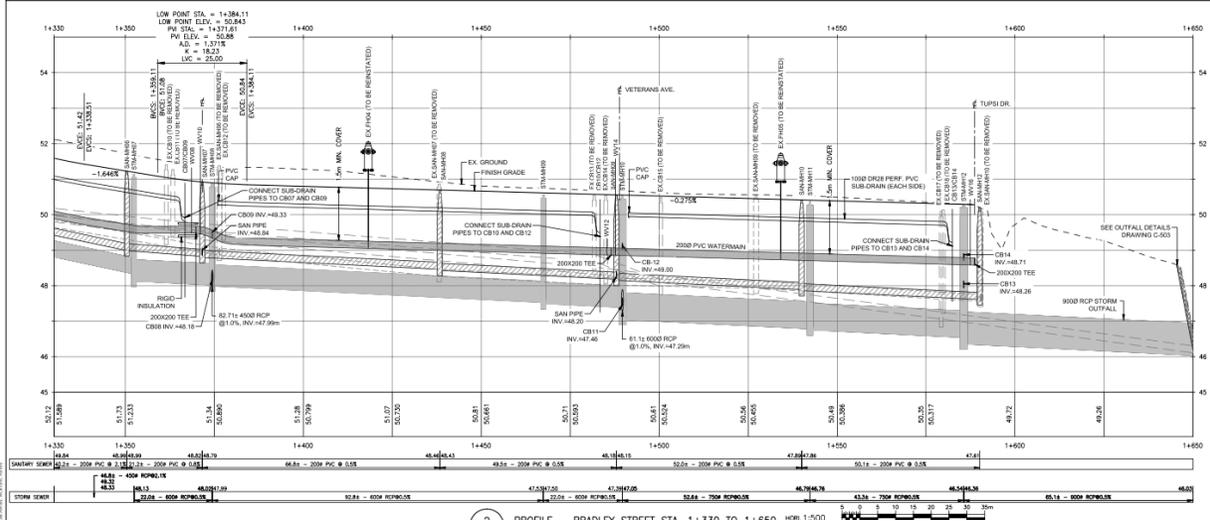
2 PROFILE - BRADLEY STREET STA. 1+330 TO 1+650  
SCALE: 1:500

# Bradley Street Engineering Plans for Full Reconstruction
